Bank revetment for a private client.

River Frome near Dorchester.

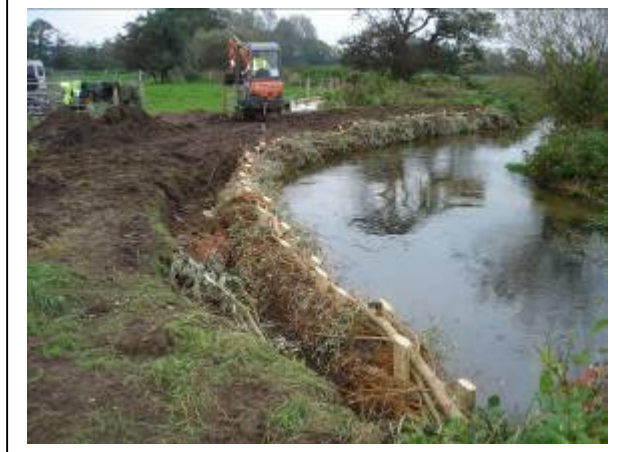
We used a considerable amount of Willow in this structure, the inside foliage once buried quickly turns into roots.

Once all necessary consents had been approved we set about driving all the posts into the river bed, a large amount of live Willow was obtained and woven into place, flush and tight to the bed of the water course to prevent any further flood damage.

We trenched five sturdy ground anchors into place as we went, ensuring the whole structure stayed in place, before all the Willow began to root in the coming spring.

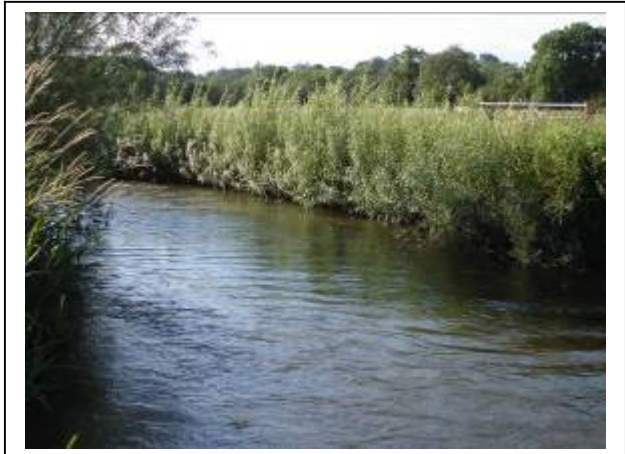
This is how the revetment looked during early summer the following year.

Come the spring, after being submerged for most of the winter (a particularly wet one) all the Willow started to grow strongly and has resulted in some great bank protection, as well as great cover for both fish and other wildlife.
